Counties (MD/PA) Harford/York

A COMPARATIVE ASSESSMENT OF THE STATUS AND CONDITION OF THE MONUMENTS ON THE MASON AND DIXON LINE.

32(34) A,B,C,D

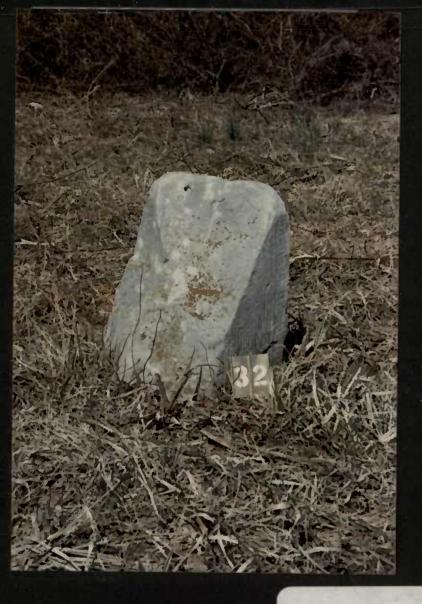
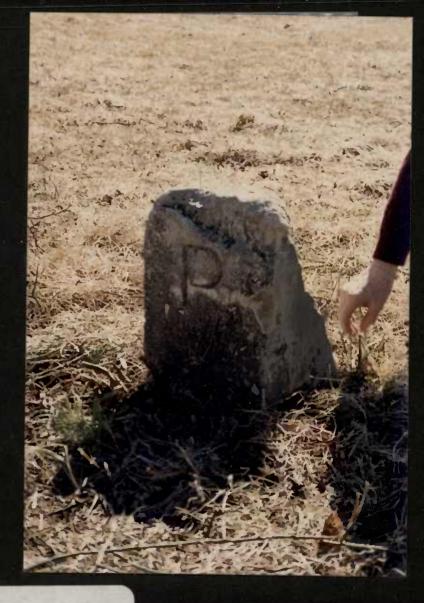
32 (34) 8 MAR 88

Although the stone is in an open field and just 30 feet from the outflow of a springhouse in a fairly low spot. the stone is firmly set and the foundation appears to be sound. Half of the exposed portion of the stone is

missing (see photo) and the North horizontal edge is badly chipped. The P is in very good condiiton and some evidence of decorative grooves remain on the East side. The stone is presently in a protected situation and

The SW corner and vert. edge are missing. The SE corner and vert. edge are missing. The NE corner rounded, vertical edge good.

The NW corner badly chipped, almost into the P, and

the vertical edge has small chips.

East, South and West horizontal edges are missing, the

North horizontal edge is badly chipped.

Status: Protected

Condition: Fair to Deteriorated

Foundation: Sound
